## **RM of Prince Albert No. 461** Slope Stability Assessment of North Saskatchewan River South Banks

09 May 2022

Prepared by: Jesse Mysiorek, B.Sc., M.Sc., P.Geo. Geotechnical Engineer

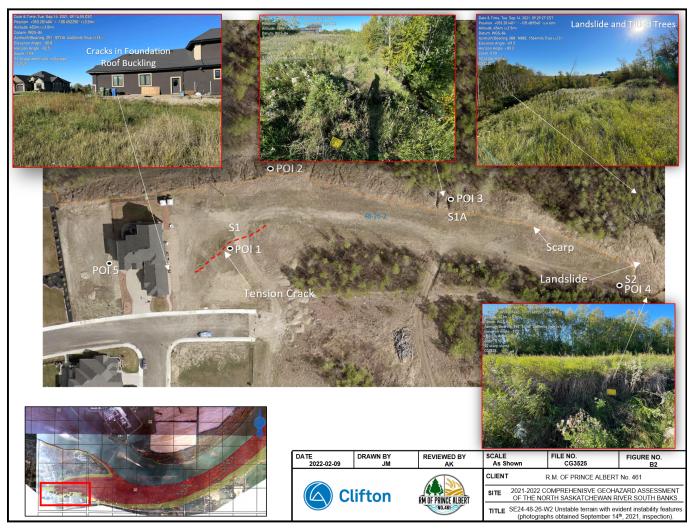
Throughout the field inspection, evidence of landslide activity in the surrounding area identified in desktop review and GIS mapping was confirmed with localized landslides (slumps) (POI 4), tension cracks (POI 1), tilted trees (POI 4), damaged houses (POI 1,5), foundations, roadways, cracked pavement and scarps (POI 3) (Figure A1.1; A2.1; B2). A major tension crack, approximately 20 m long and 15 cm dilation (width) trending northeast to southwest was identified nearly 12 m east of a residence house (Figure B2). The slope is characterized as undulating to moderately rolling in the uplands, with the mid to lower slopes having a hummocky horst and graben morphology (landslide blocks), characteristic of deep-seated landslide terrain in a meta-stable condition. Deep seated landslide movement is evident with previous slope inclinometers monitored from 2017 to 2019 indicating landslide movement at a shear zone at ~29 mbgs (Clifton File No. R5999).

Figure B2 – Identified instability features along unstable slope within SE 24 – 48 - 26 – W2.

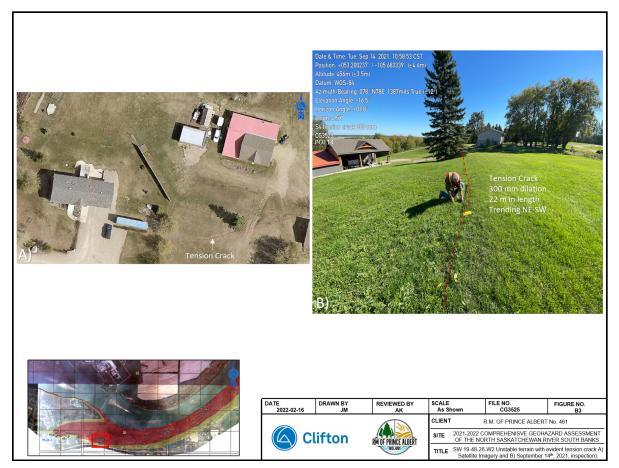
The slope is characterized as undulating to moderately rolling in the uplands, with the mid to lower slopes having a hummocky horst and graben morphology, characteristic of deep-seated landslide terrain blocks in a meta-stable condition. The field inspection was focused near a house on the uplands adjacent Highway 302 which had visible cracks, foundation issues, deformed window frames, and buckled shingles (Figure A1.1; A2.1; B3). Multiple tension cracks were identified in previous reports, GIS mapping and field inspection, with the smaller crack west of the house approximately 10 m long and 1 cm dilation (width) trending east to west. A large tension crack, approximately 25 m long and 30 cm dilation (width) trending northeast to southwest was identified east of the house on the high-resolution satellite imagery and ground truthed during the field inspection (Figure A1.1; A2.1; B3; POI 14). When the more recent (east) major tension crack (POI 14) formed is unknown, although, based on available reports and satellite imagery, it appears that the crack developed between 2011 to 2021. This slope is classified as unstable, and with limited subsurface datasets, the nature of the movement is unknown without site specific geotechnical investigation and monitoring.

Figure B3 – Identified major tension crack along unstable slope within SW 19 - 48 - 26 – W2.

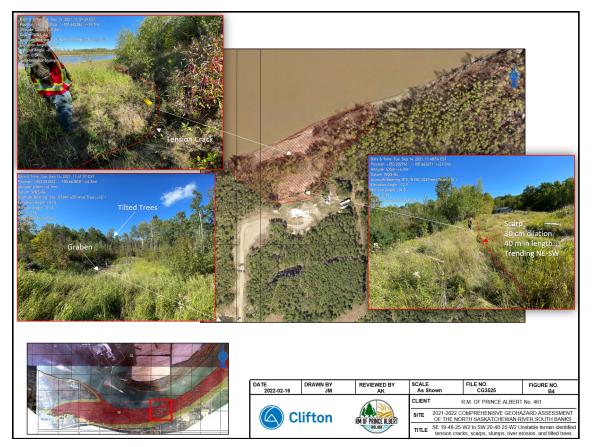
Clifton was informed by the RM that a resident was removed from the property due to ground movement. This area had clear evidence of slope instability identified during the desktop study and hazard mapping. During the field inspection, Clifton staff confirmed the presence of major slope instability features including localized landslides (slumps) (POI 18), scarps (POI 17), river erosion, disturbed trees, and tension cracks (POI 18, 19) (Figure A1.1; A2.1; B4). A major tension crack, approximately 20 m long and 30 cm dilation (width) trending northeast to southwest was identified intersecting the access road to the property (POI 19). The slope is characterized by a hummocky horst and graben morphology (landslide blocks) associated with deep-seated landslide terrain in a meta-stable condition (Figure B4). This type of ground deformation has the same surficial instability features that are seen throughout the entire lower riverbank, with scarps, tension cracks, tilted trees and horst and graben linear features following a similar orientation (e.g., northeast to southwest).

Figure B4 – September 14<sup>th</sup>, 2021, Clifton field ground-truthed and GIS mapped slope instability features along the North Saskatchewan River south slope (SE 19-48-25-W2 to SW 20-48-25-W2).

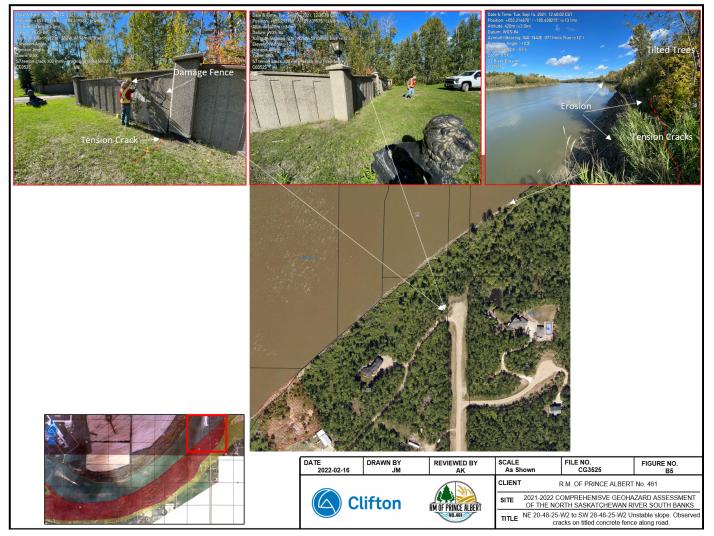
**4.2.4 NE 20-48-25-W2M to SW 28-48-25-W2M: Tilted Fences, Slumps, River erosion, Landslides** The RM informed Clifton that cracks were observed on the tilted concrete fence along the road. Clifton was able to identify changes in this area, classifying the slope as unstable during the desktop review and GIS mapping because of large linear landslide features such as scarps and grabens, river erosion, and slumps (Figure A1.1; A2.1; B5). During the field inspection, Clifton staff confirmed the unstable ground features, which included a tension crack trending northeast to southwest that intersected and damaged a concrete fence (POI 20) as well as tilted trees, slumps, and river bank erosion (Figure B5).

Figure B5 – Identified major slope instability features along unstable slope causing slope deformation and property damage.

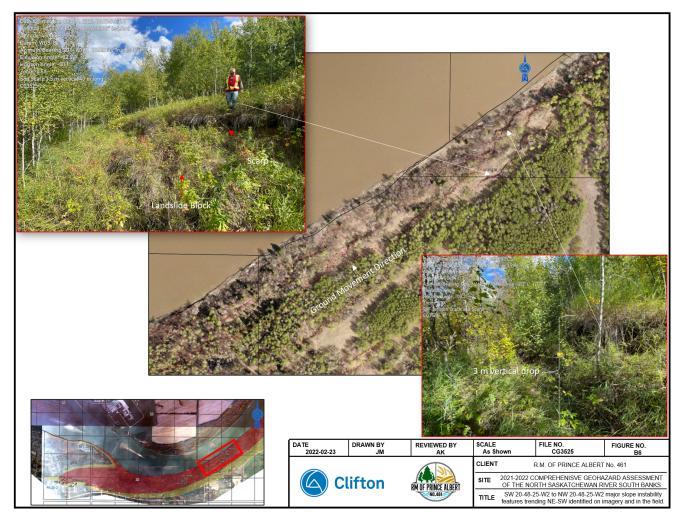
**4.2.5 SW 20-48-25-W2M to NW 20-48-25-W2M: Tension Cracks, Scarps, River Erosion, Landslides** Prior to the field inspection, Clifton was able to identify mid to lower undulating and hummocky landslide slopes within 300 m of the river throughout the area (Appendix A1.1; A2.1). The main landslide features evident on satellite imagery and confirmed during the field inspection included multiple repetitive, large scale (e.g., nearly 60 m long, 3 m dilation, 4 m high and trending northeast-southwest) tension cracks, and scarps that made up hummocky horst and graben landslide blocks characteristic of deep-seated landslide terrain and progressive failure near the toe of the slope (river) (Figure A1.1, A2.1; B6). This area is highly unstable due to progressive slope movement and continuous undercutting/erosion of the outside bend of the river.

Figure B6 – Identified major slope instability features (scarps, tension cracks, tilted trees, and landslide blocks) along a highly unstable slope. Note the repetitive northeast-southwest orientation of the landslide deformation blocks.

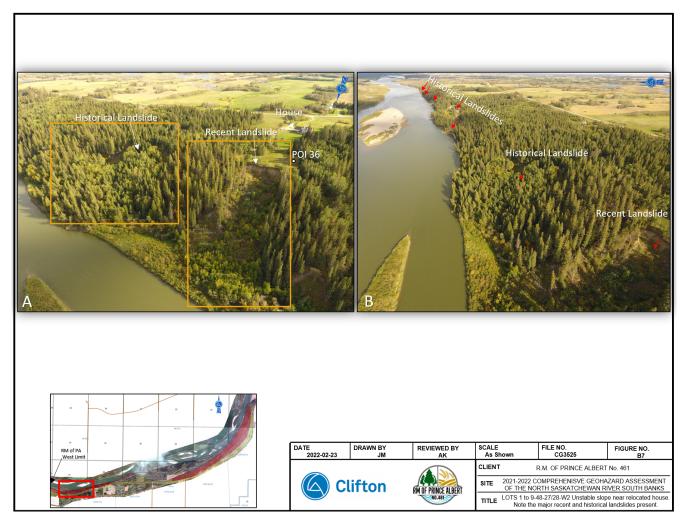
Desktop review, remote sensing, GIS mapping and background information revealed that this slope had recently experienced a large-scale (e.g., 160 m length, 60 m width, 40 m height) translational landslide, which had directly affected the residence (Figure B7; A1.0; A2.0; POI 36, 37). Although the house was not directly damaged from the landslide, it had to be relocated approximately 165 m south (upslope) of the recent landslide headscarp (unstable terrain boundary) (Figure B7). Clifton ground-truthed this area by foot and deployed a quadcopter UAV to assess the current stability. As shown in Figure B7, the entire slope, including approximately 160 m upslope from the riverbank, from the western RM of PA boundary to 3 km east had experienced similar historical landslides. Although the date of the historical landslides is unknown, the dense vegetation and mature trees on the landslides indicate they occurred over 50 years ago.

Figure B7 – Unstable slope near relocated house. Note the major recent and historical landslides present.

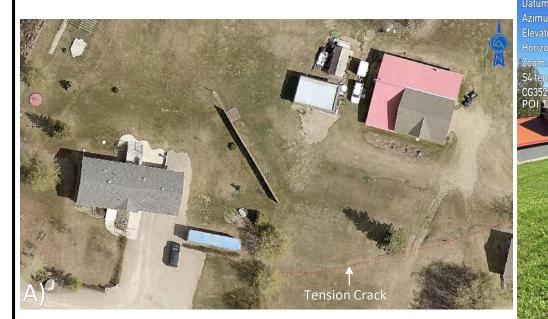
Date & Time: Tue, Sep 14, 2021. 10-58:53 CST Position: +053.200237° / -105.683339° (±4.6m) Altitude: 456m (±3.5m) Datum: WGS-84 Azimuth/Bearing: 078° N78E 1387mils True (±12°) Elevation Angle: -16.5° Horizon Angle: +01.8° Zoom: 0.5% \$4 tension crack 300 mm

> Tension Crack 300 mm dilation 22 m in length Trending NE-SW

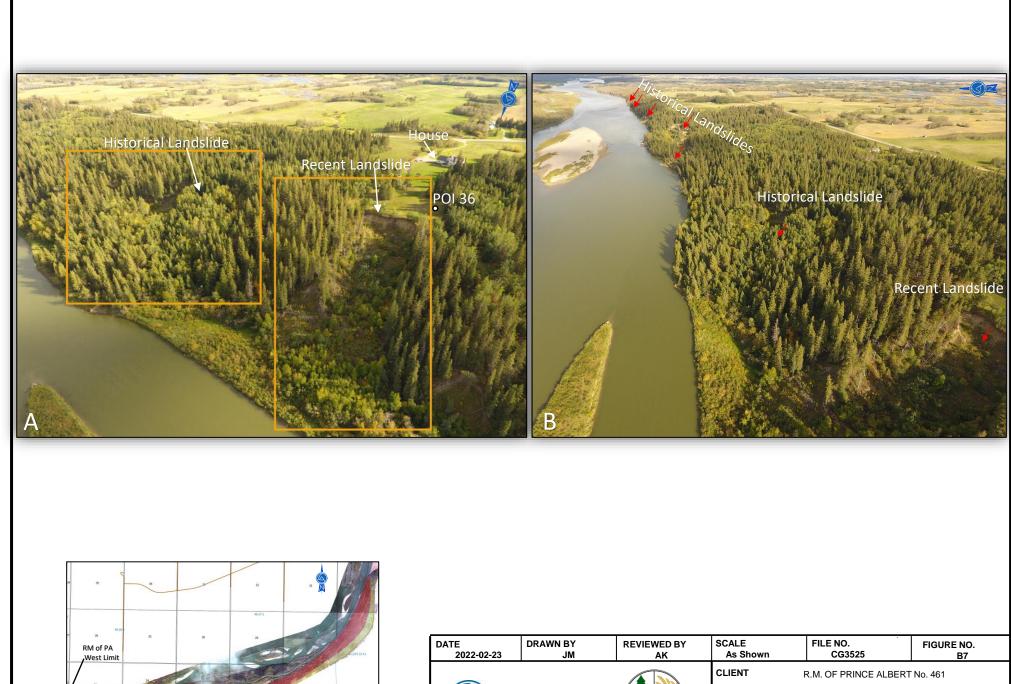
TITLE LOTS 1 to 9-48-27/28-W2 Unstable slope near relocated house. Note the major recent and historical landslides present.

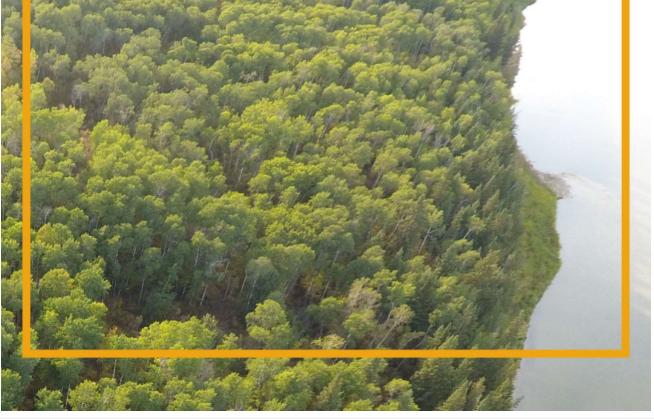
Summary: POI 39: Historical slope failure on outside cut-bank of river. Note previous debris deposit into river (toe).

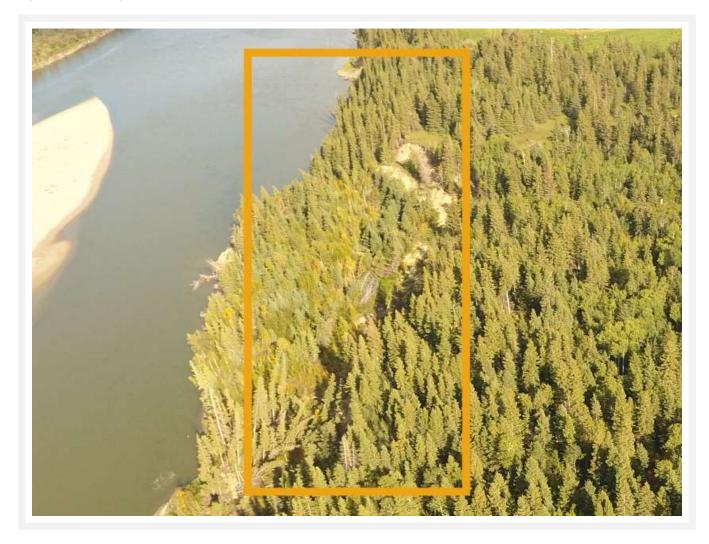
Summary: S12: Note the entire riverbank towards east has experienced historical and current landslides/deformation

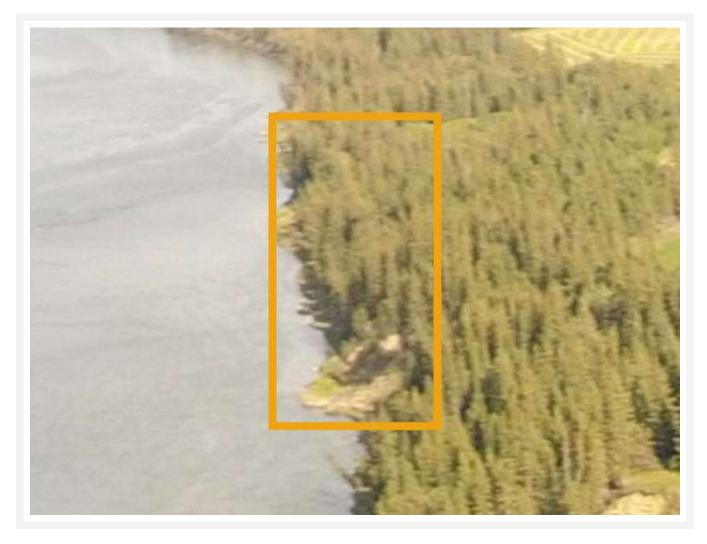
Summary: S12: Note the entire riverbank towards east has experienced historical and current landslides/deformation

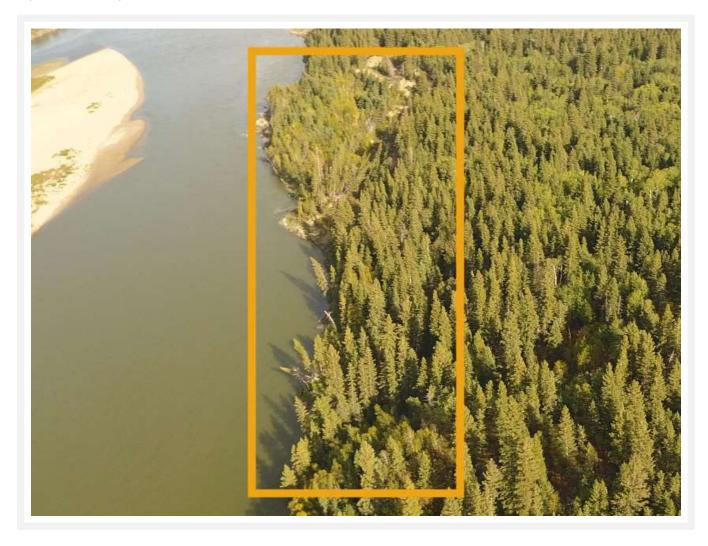
Summary: S12: Note the entire riverbank towards east has experienced historical and current landslides/deformation

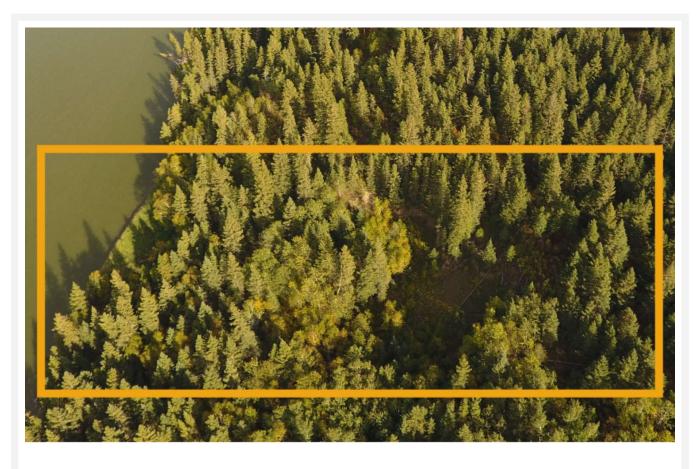
Summary: S12: Note the entire riverbank towards east has experienced historical and current landslides/deformation

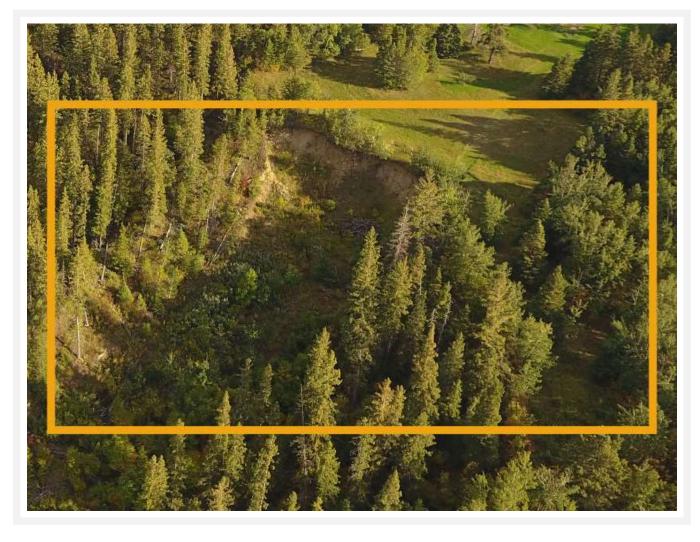
# 11 - Landslide

Recent Landslide Nov 17, 2021, 4:34pm by Jess Mysiorek

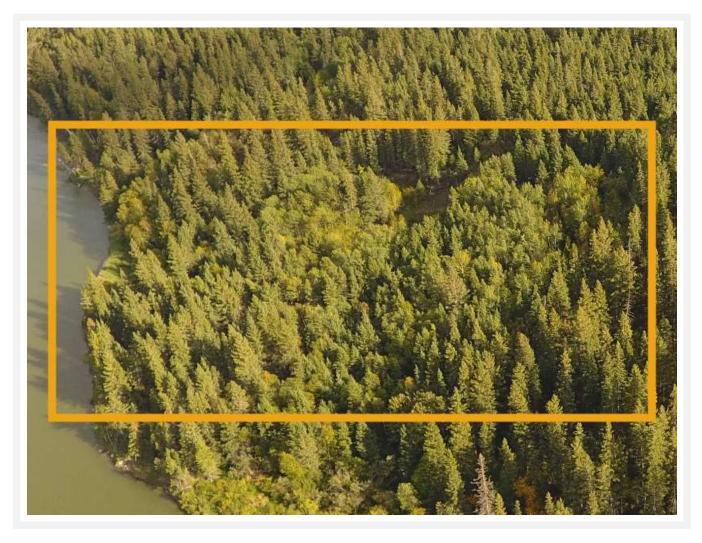
Historical (>100 year) Slope Failure Nov 17, 2021, 4:34pm by Jess Mysiorek

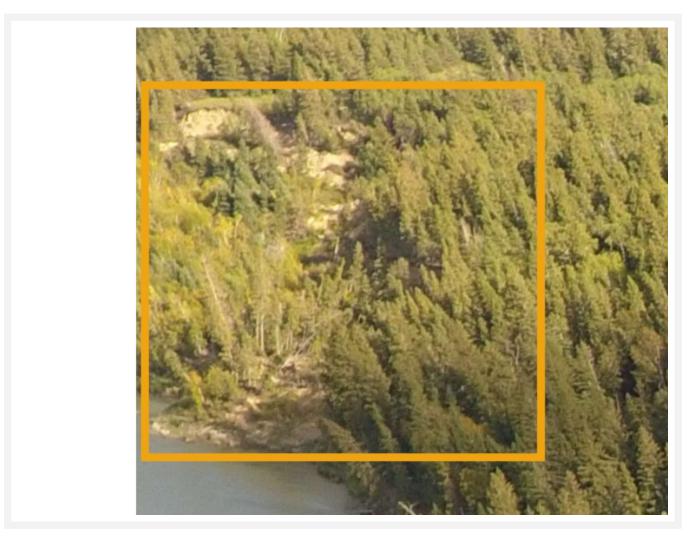
Recent Slope Failure Nov 17, 2021, 4:33pm by Jess Mysiorek
